# Fergus and Judith Basin Counties Remaining Prospects

Final Report  
Abandoned Mine Reclamation Project

## FERGUS AND JUDITH BASIN COUNTIES REMAINING PROSPECTS ABANDONED MINE RECLAMATION PROJECT

Robert Peccia & Associates, Inc.  
Helena, MT

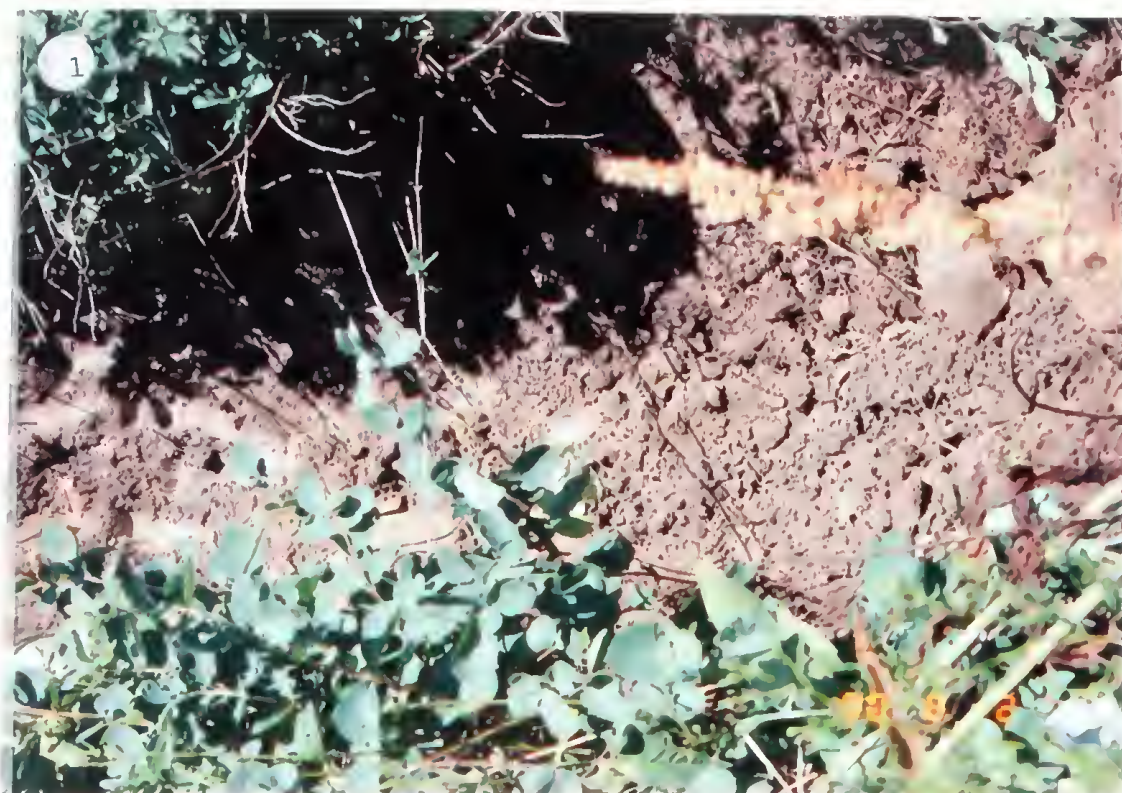
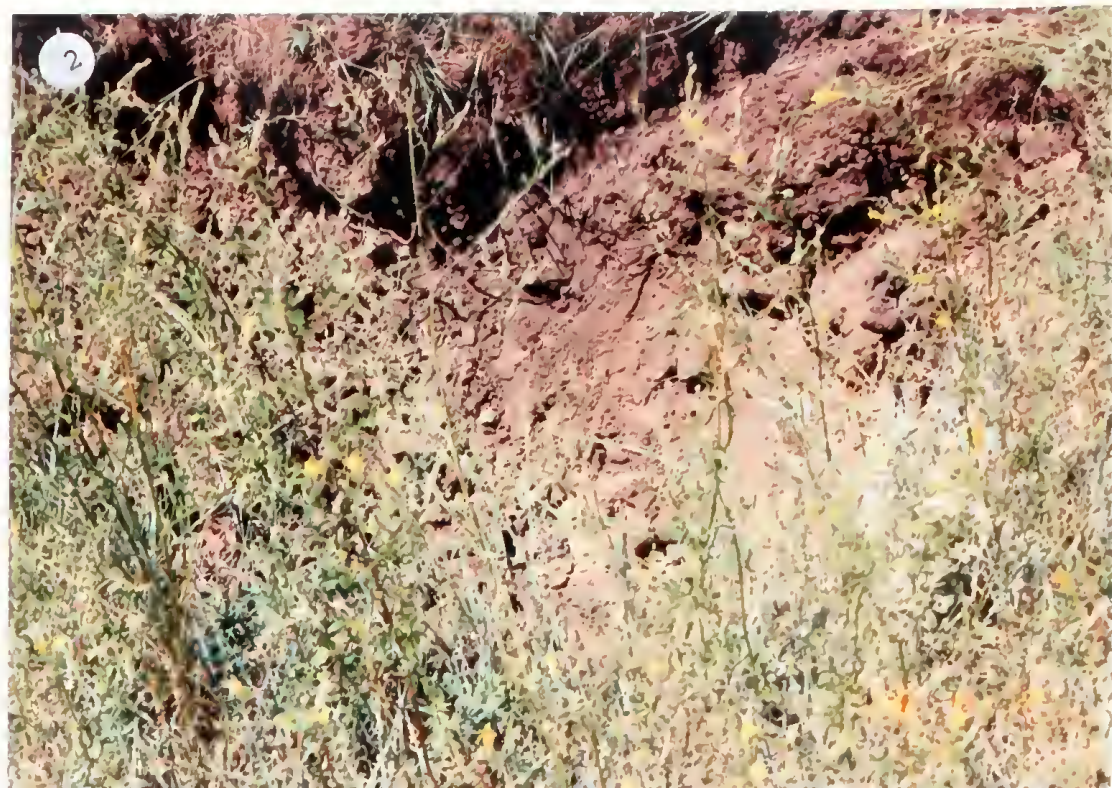
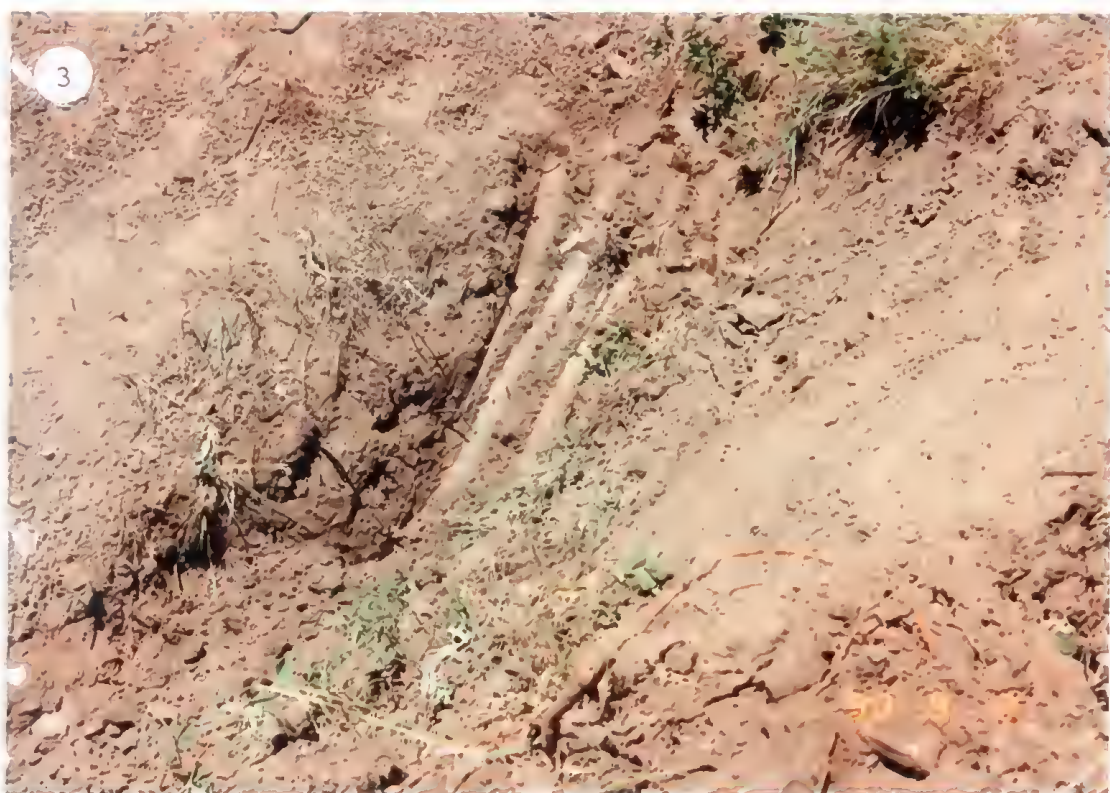
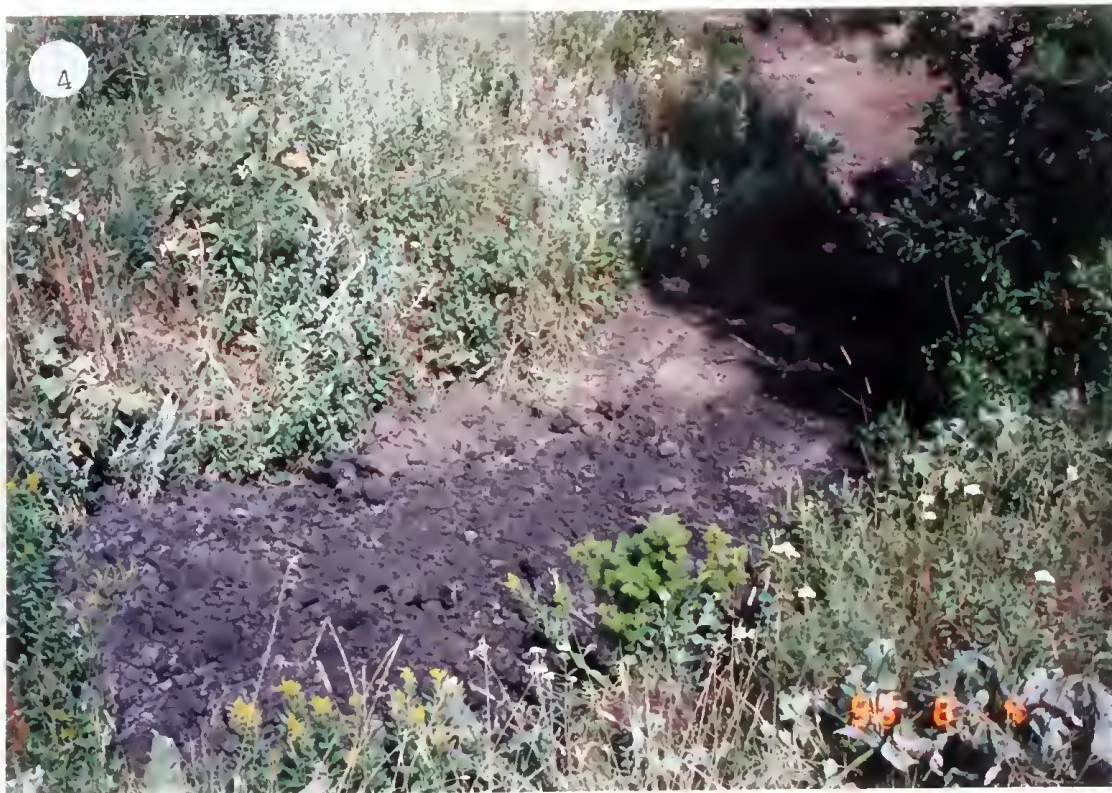
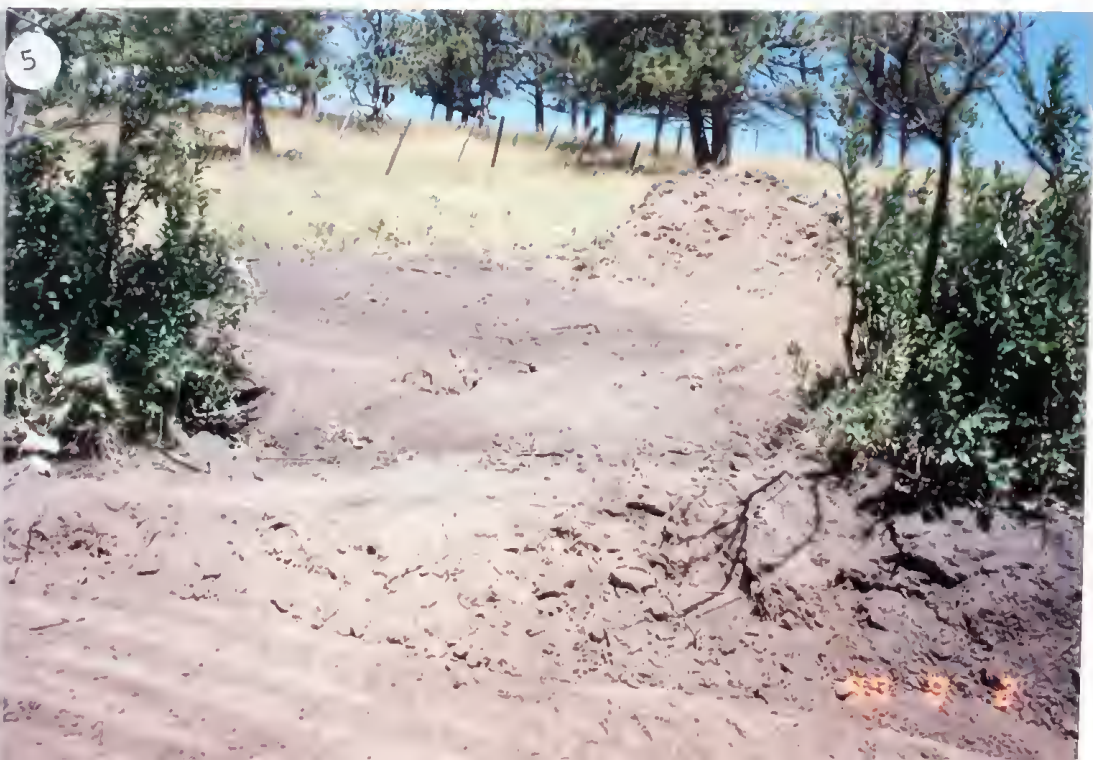
1. Shearson Mines - Site No. 1 Adit Exploration
2. Shearson Mines - Site No. 2 Adit Exploration
3. Shearson Mines - Site No. 3 Adit Exploration
4. Shearson Mines - Site No. 5 Spoils Deposition
5. Shearson Mines - Site No. 1 Spoils Deposition

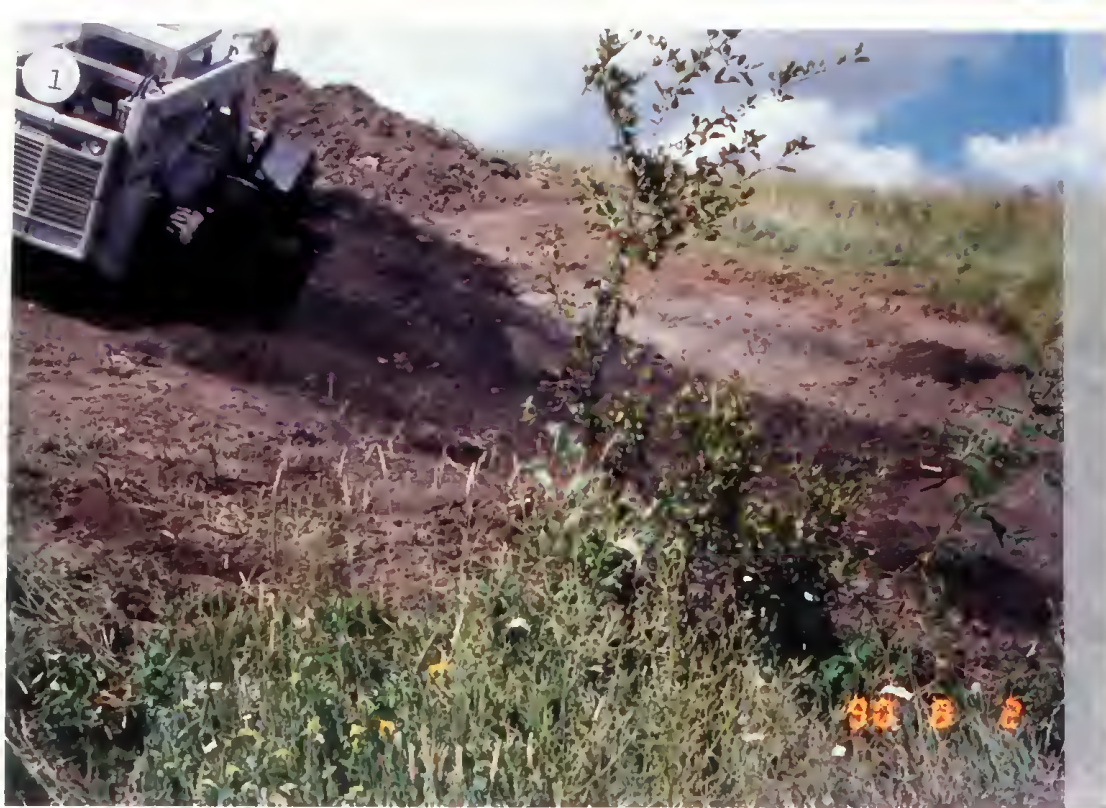
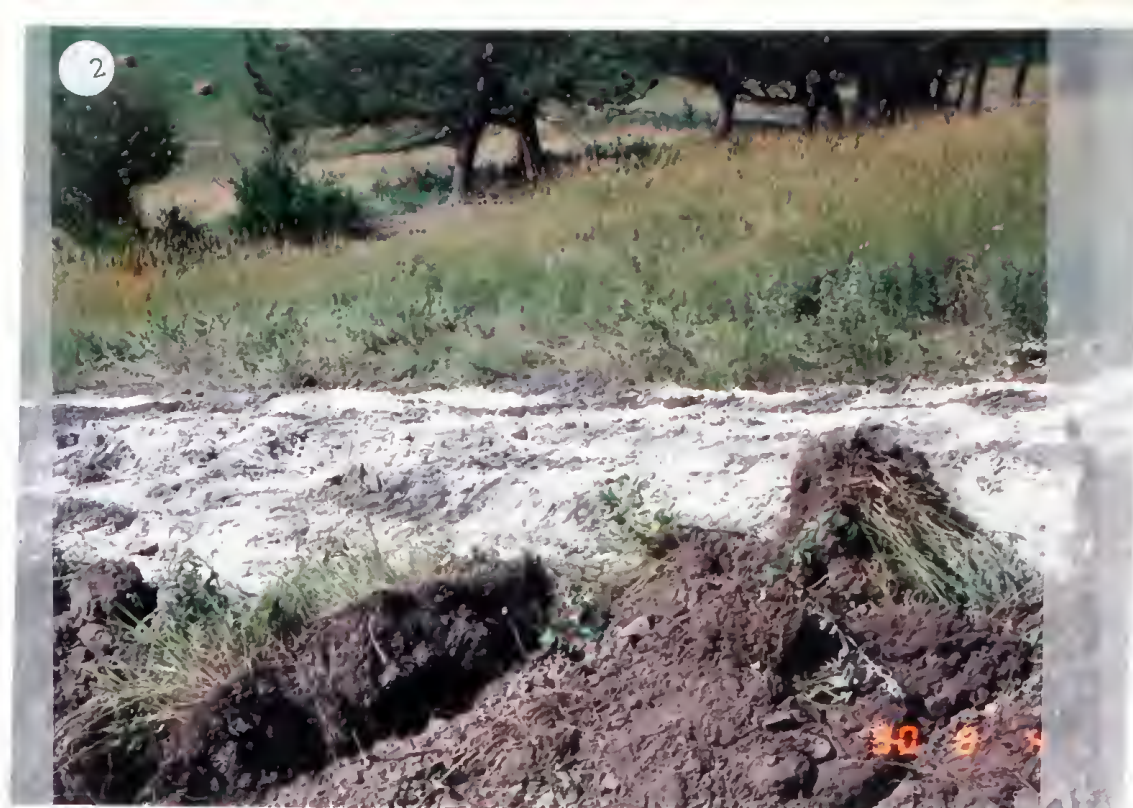
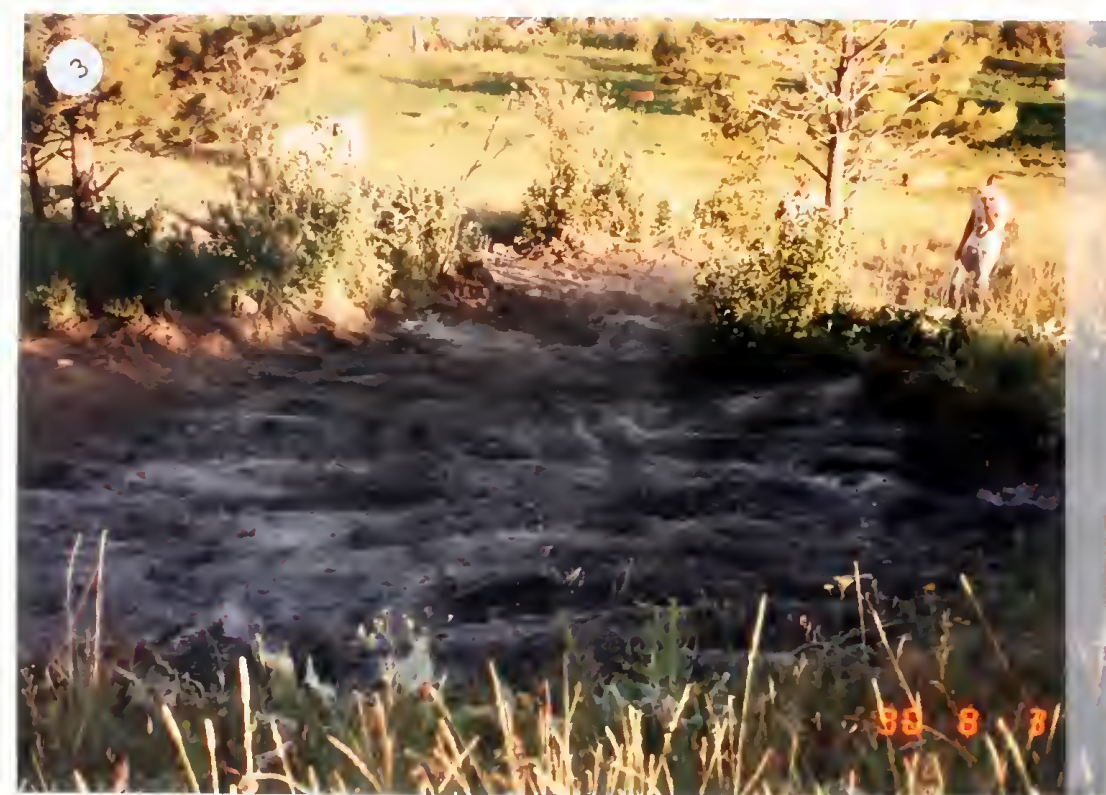
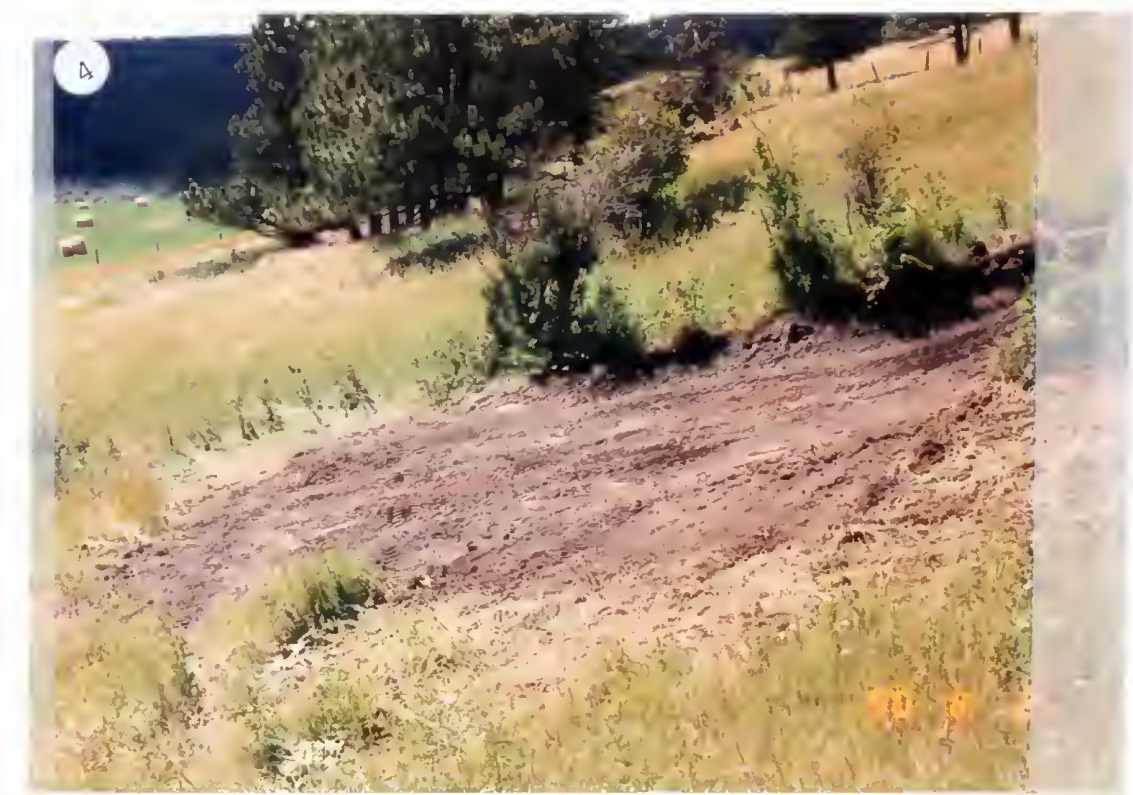
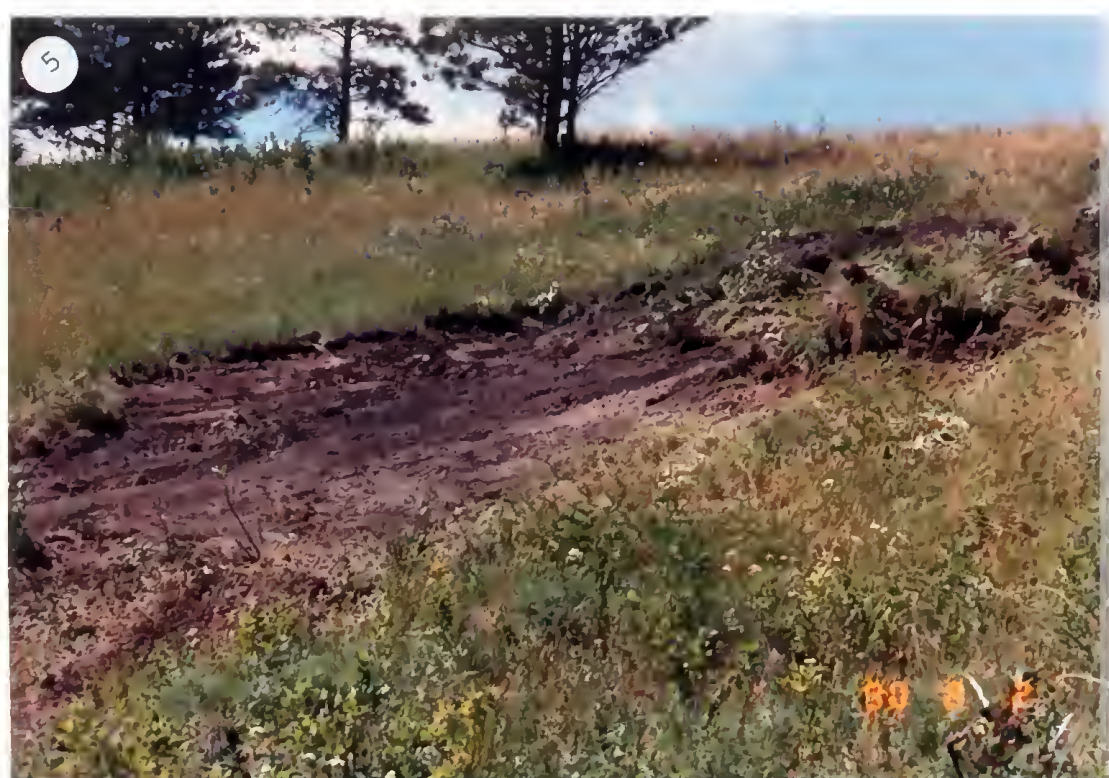
1. Shearson Mines - Site No. 2 Spoils Deposition
2. Shearson Mines - Site No. 2 Lime Application
3. Shearson Mines - Site No. 1 Lime Incorporation
4. Shearson Mines - Sites No. 2 & 3 Coversoil Borrow Area
5. Shearson Mines - Site No. 1 Coversoil Stockpile

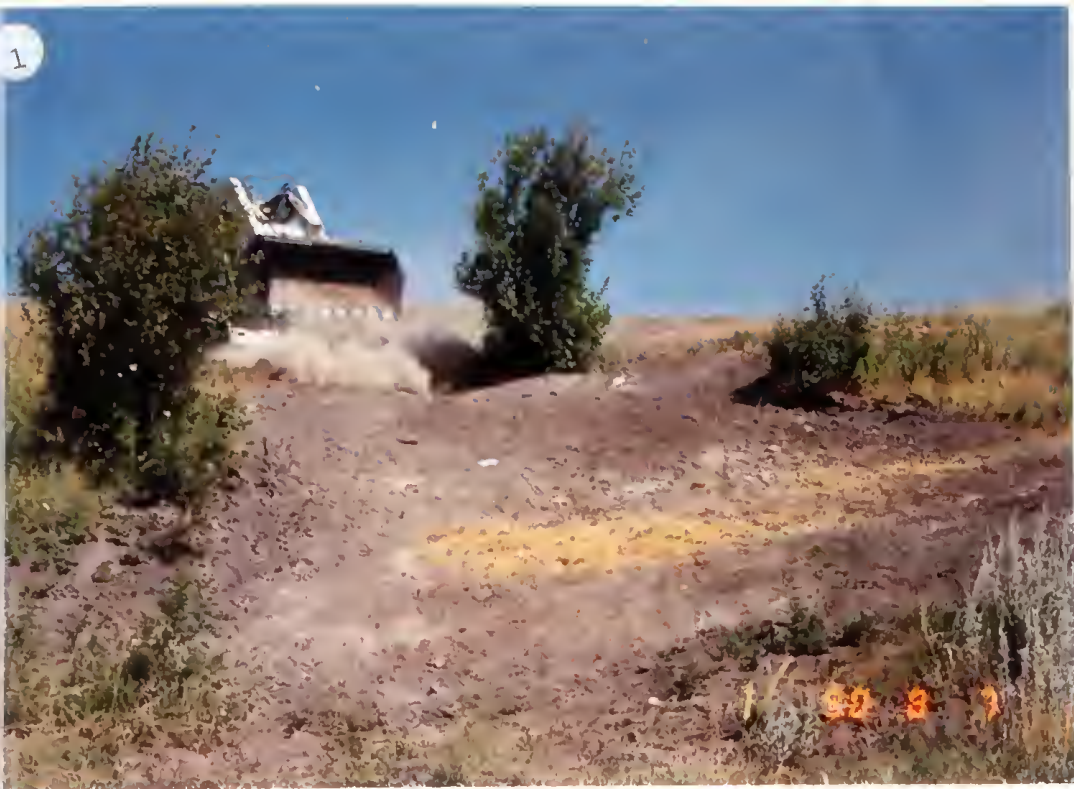
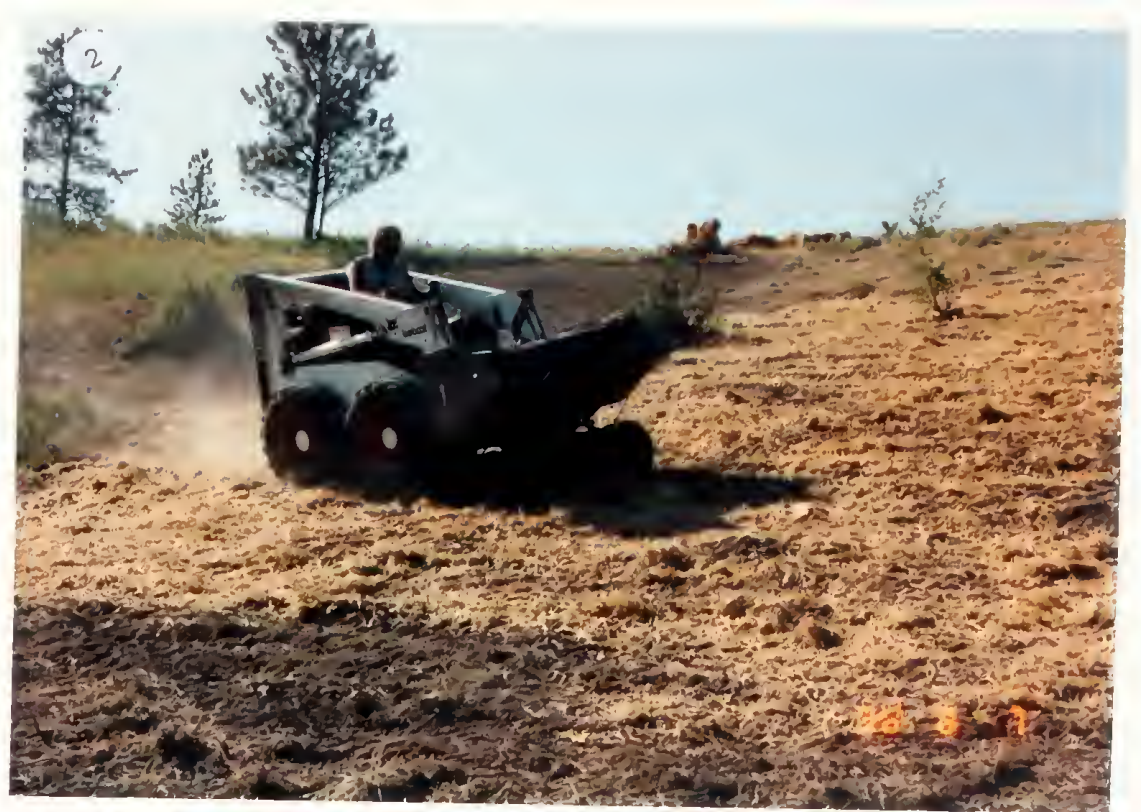
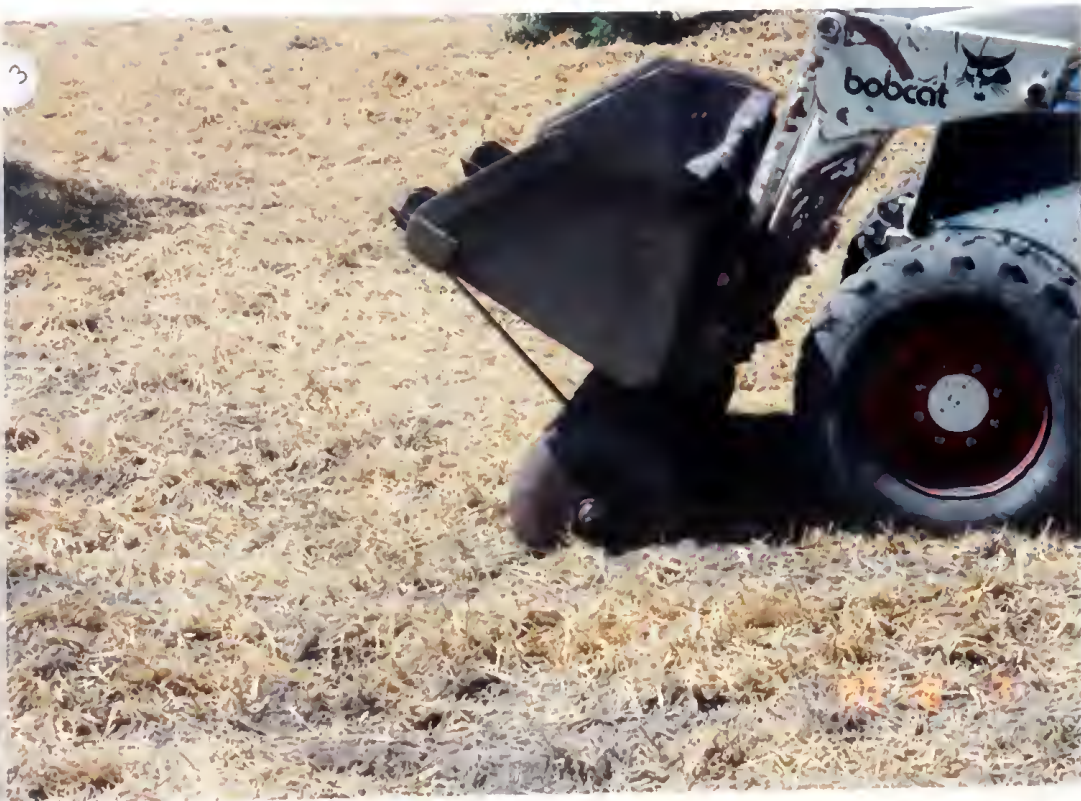
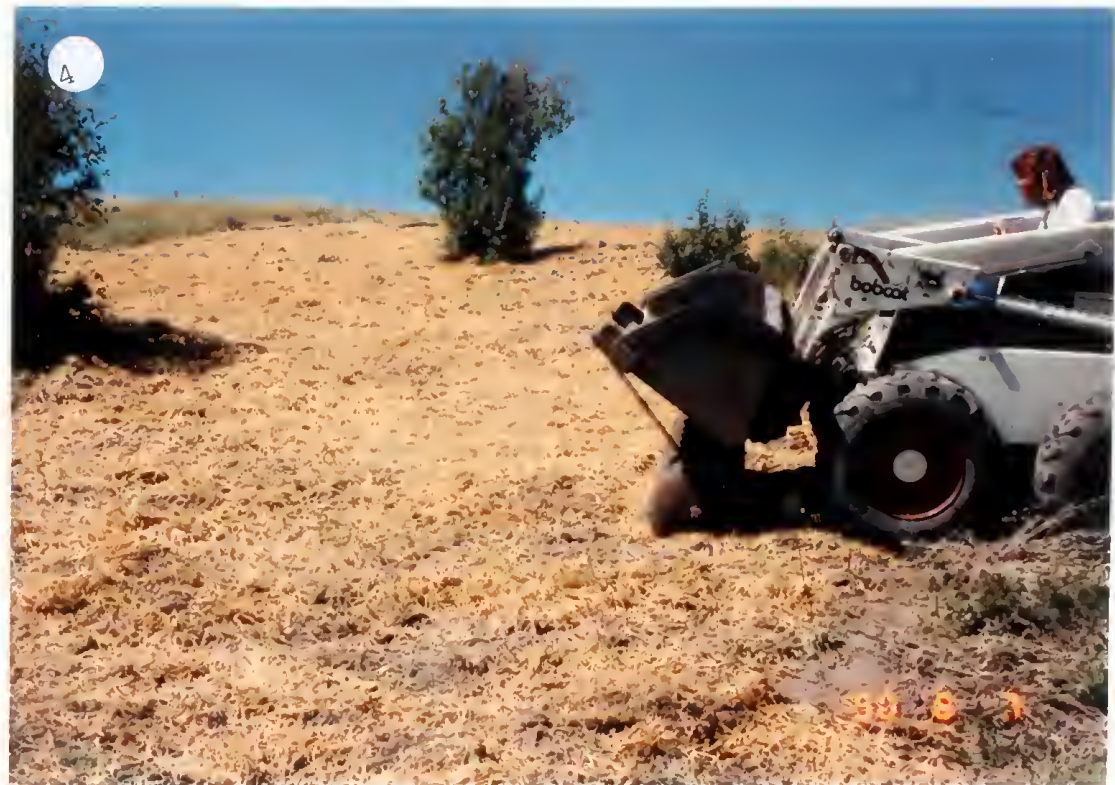
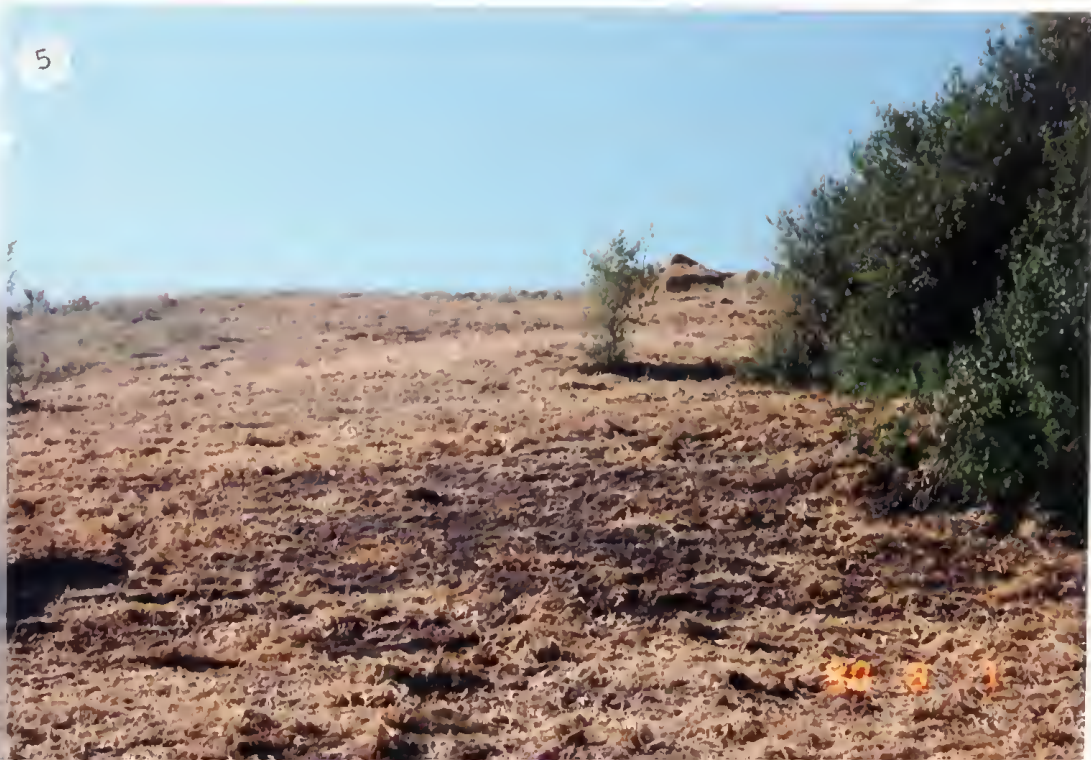
1. Shearson Mines - Coversoil Placement at Site No. 4
2. Shearson Mines - Mulch Crimping at Site No. 3
3. Shearson Mines - Close-up of Initial Crimping Tool (This was later replaced)
4. Shearson Mines - Mulch Crimping at Site No. 4
5. Shearson Mines - Mulch Cover at Site No. 3

poorly. The Contractor was informed that his crimping results were not meeting specifications. He said that he was in the process of having a crimping tool attachment fabricated to fit the Bobcat bucket that would meet specifications for performance. An agreement was reached that the Contractor would have to return and remulch and recrimp each of the sites that failed to retain mulch at the seed date.

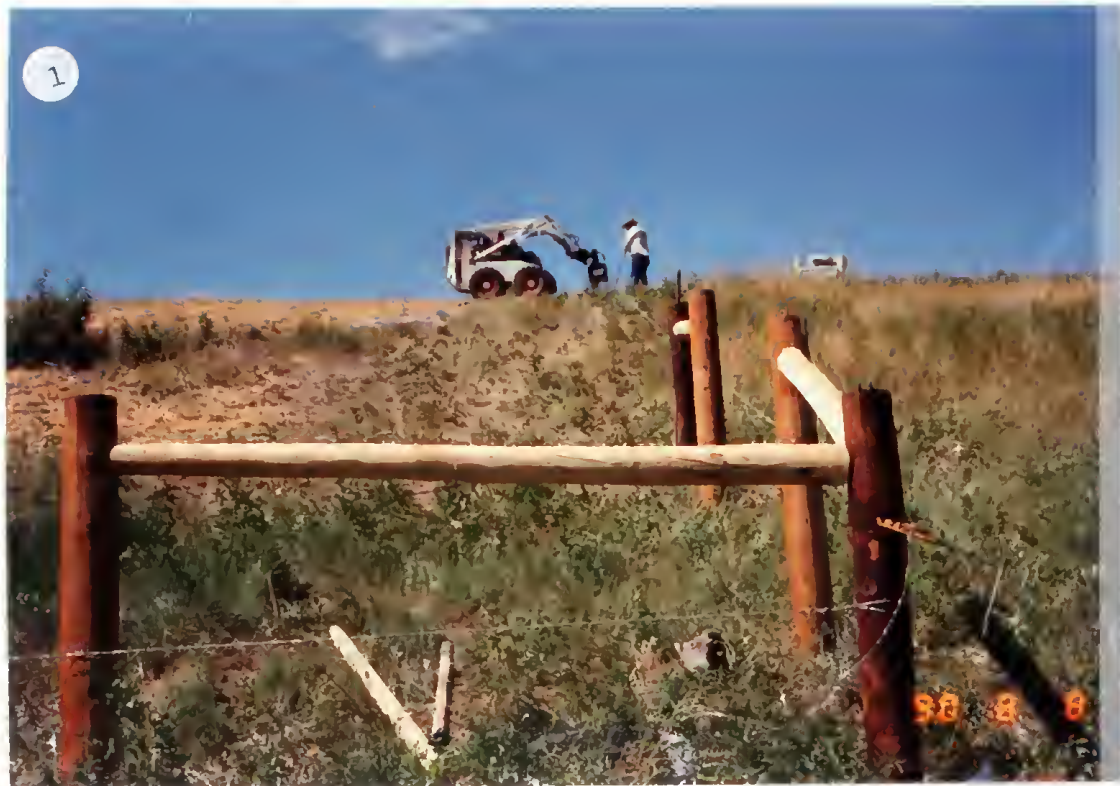
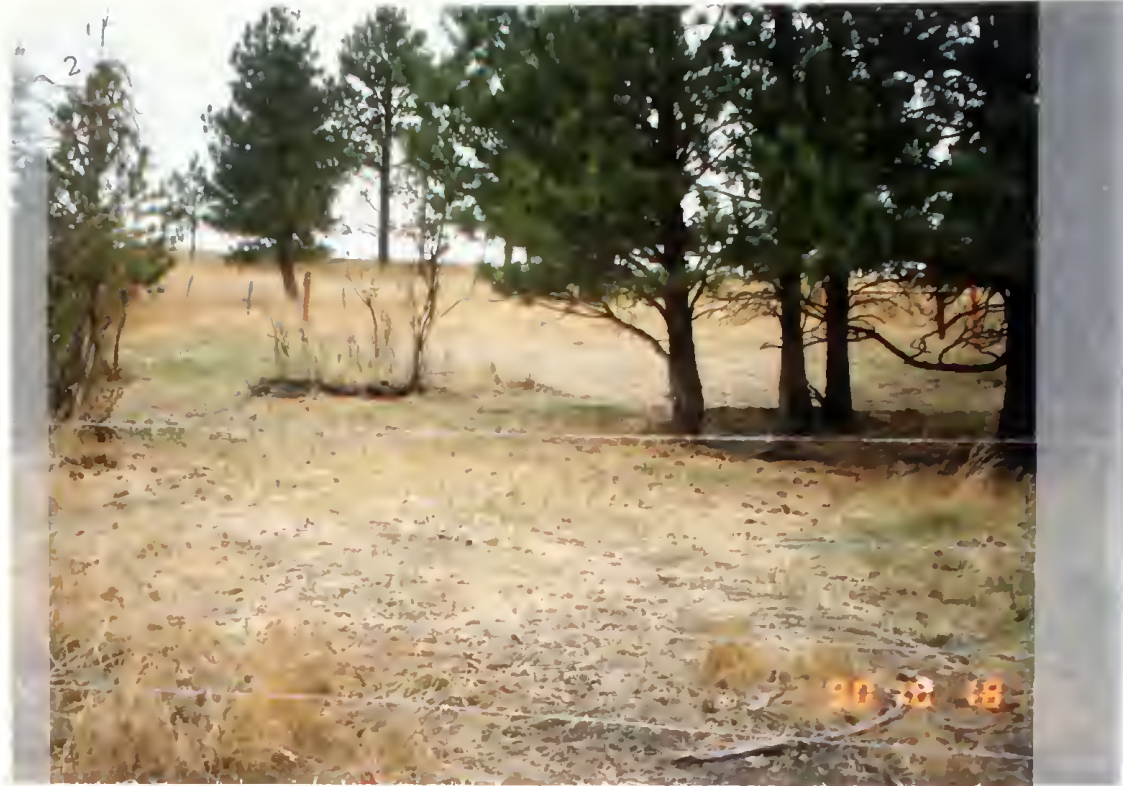
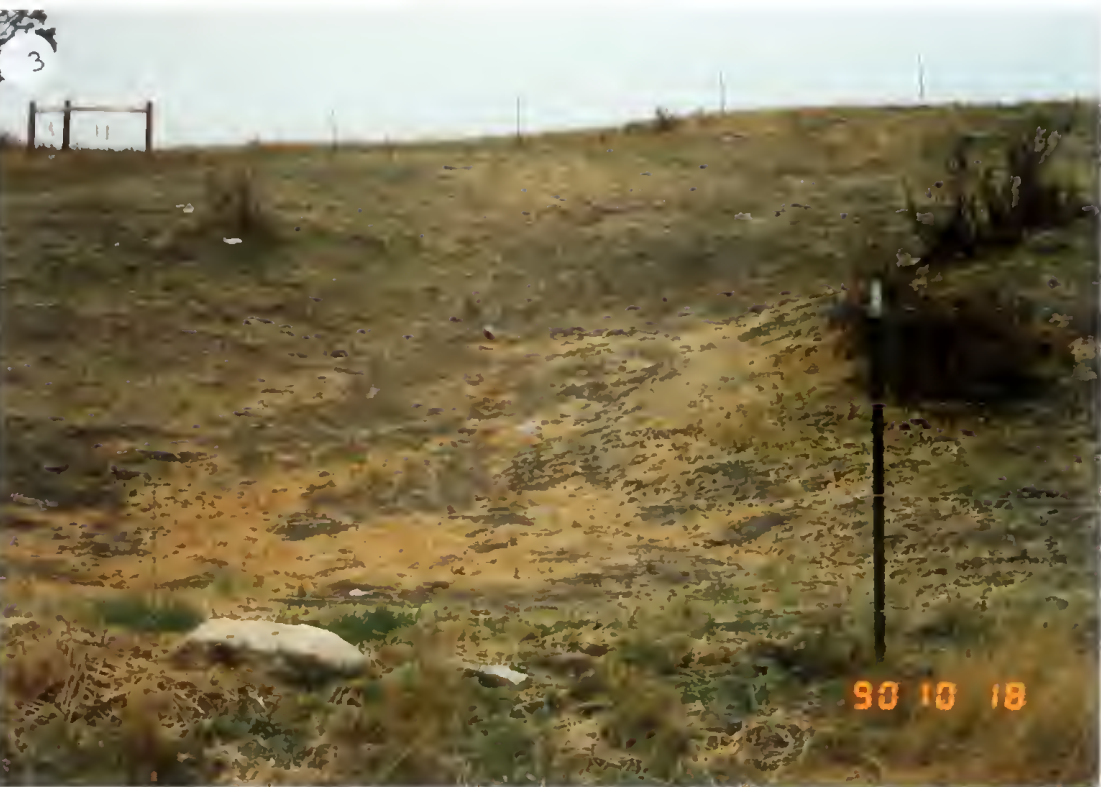
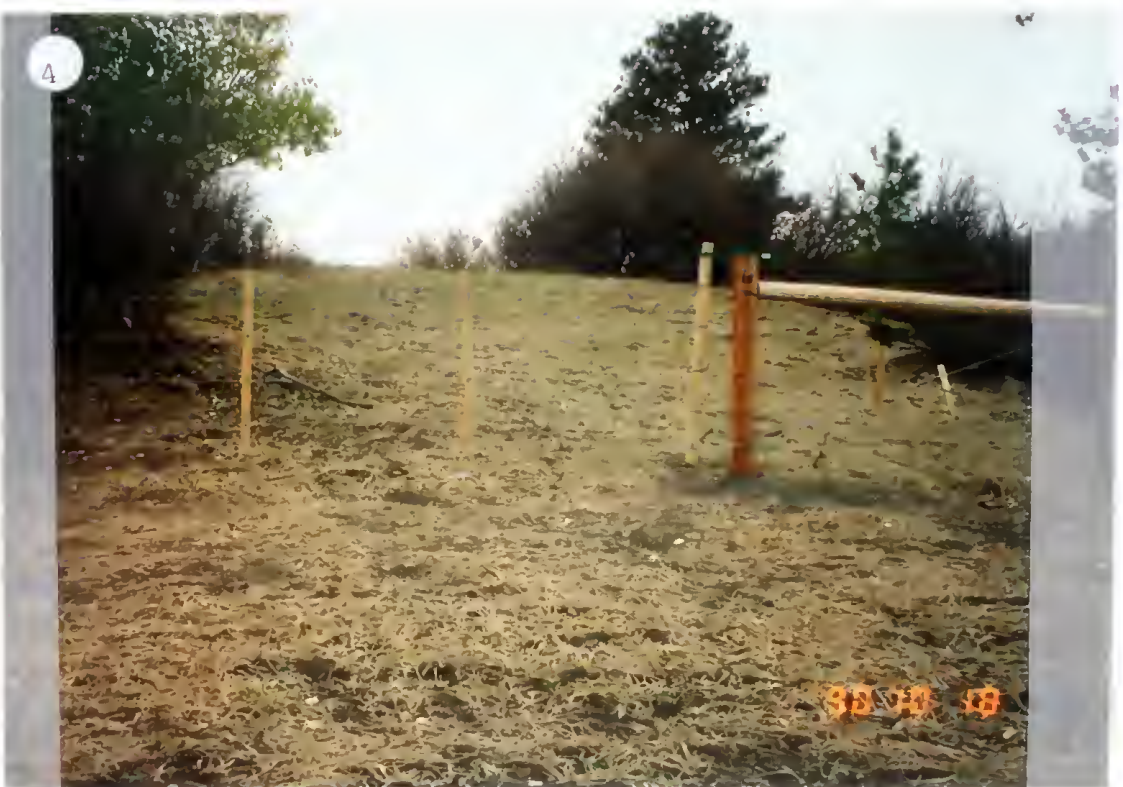
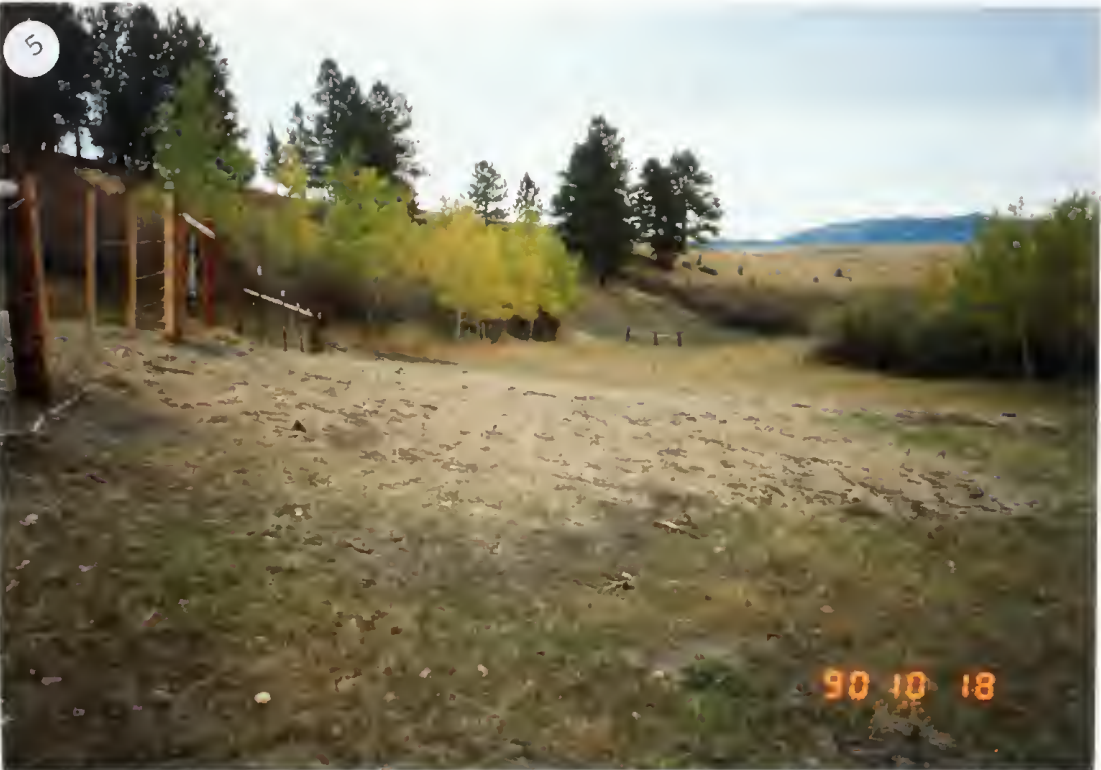
1. Shearson Mines - Fence Construction Around Sites 2,3,& 4
2. Shearson Mines - Site No. 1 After Reclamation
3. Shearson Mines - Sites No. 2 & 3 After Reclamation
4. Shearson Mines - Site No. 5 After Reclamation
5. Shearson Mines - Site No. 5 Reclaimed Area in Farm Field Below Site

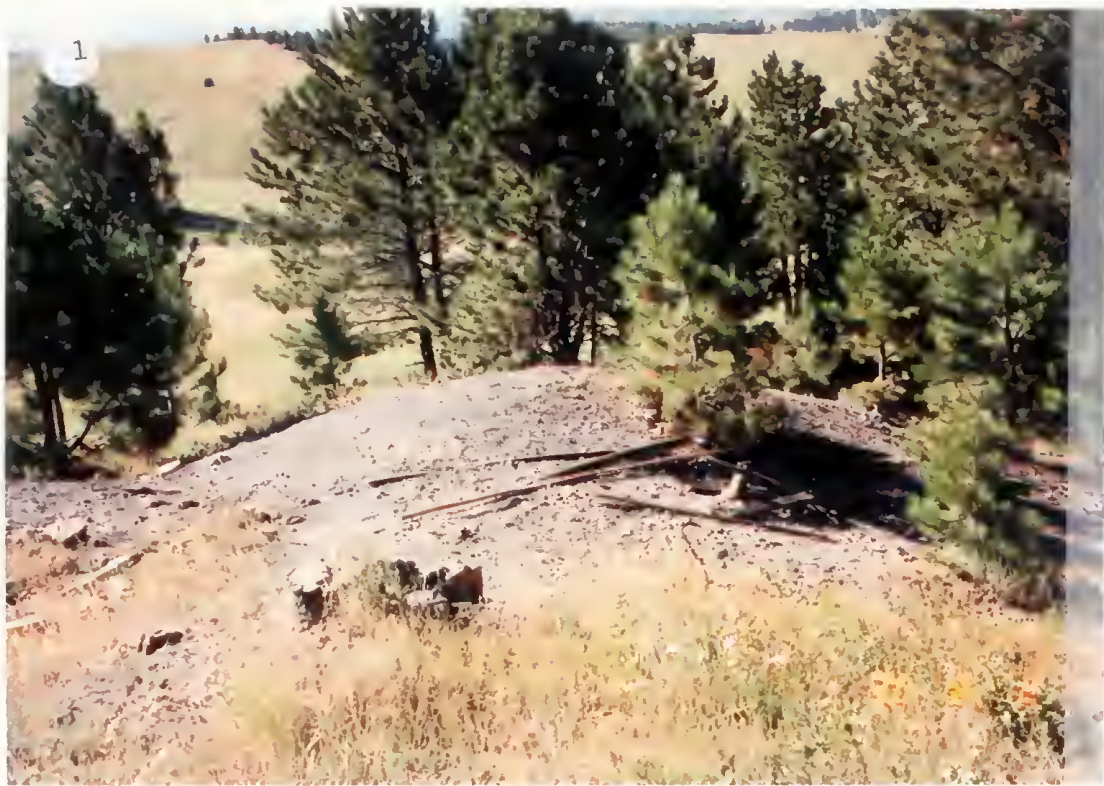
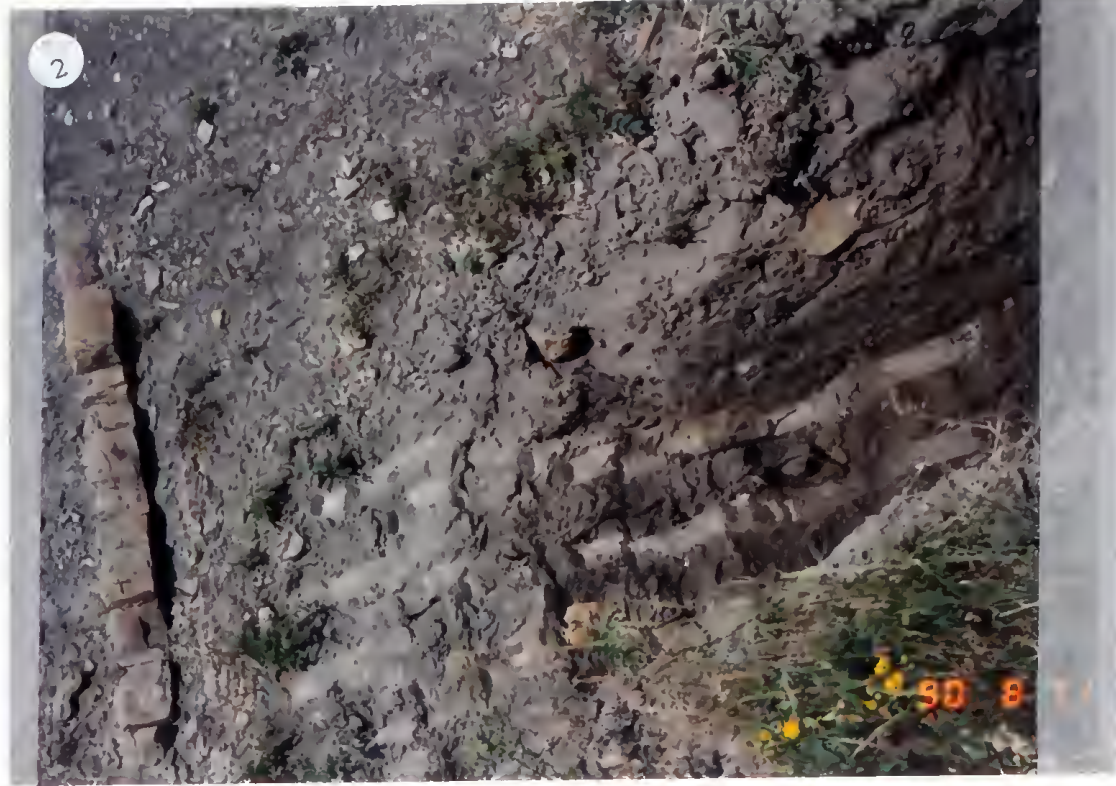
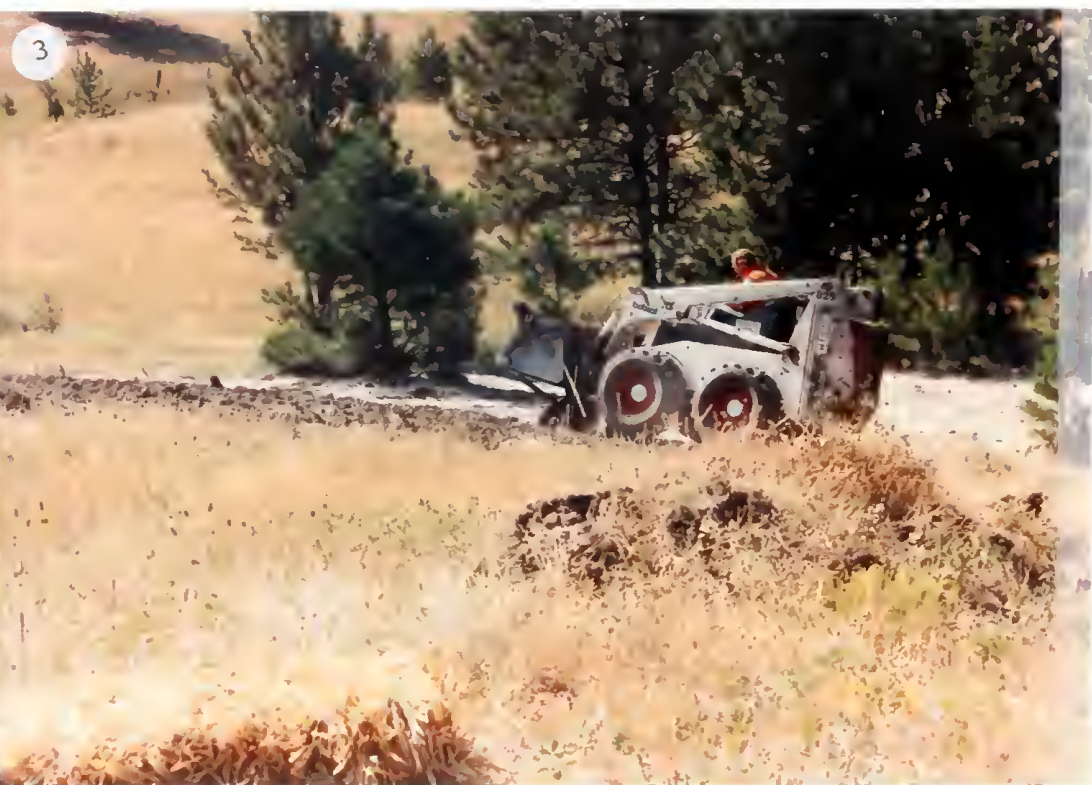
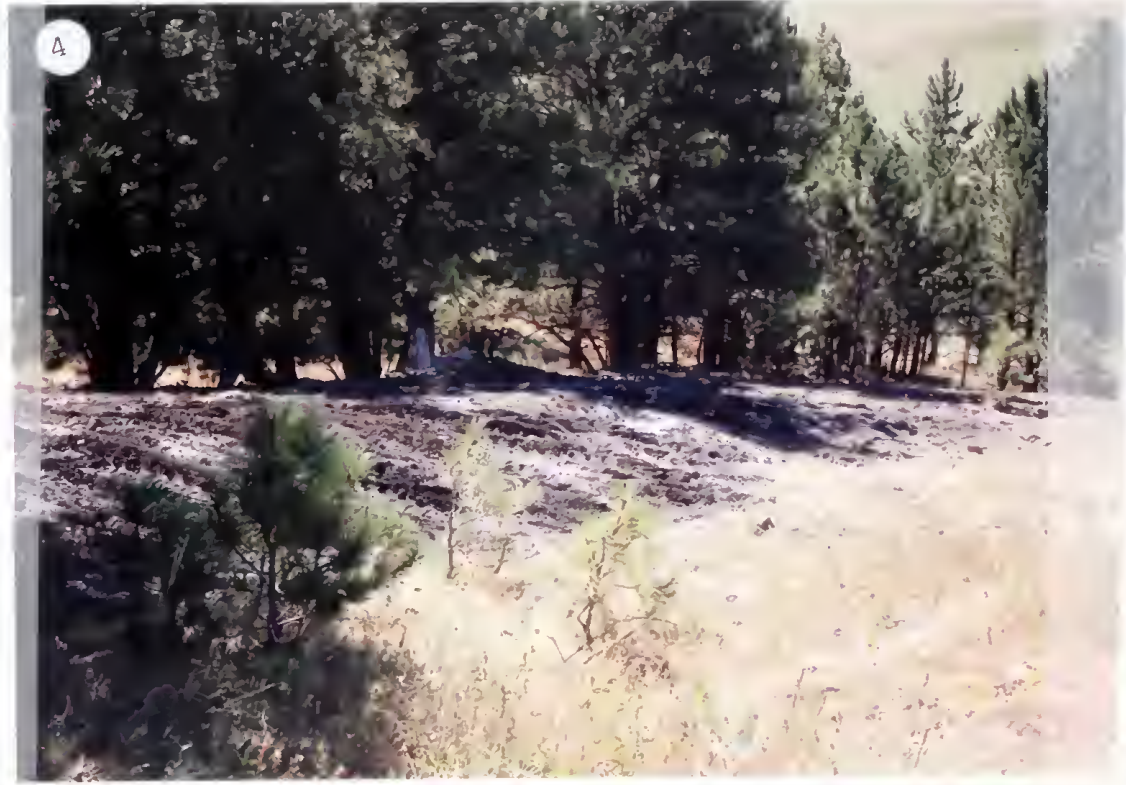
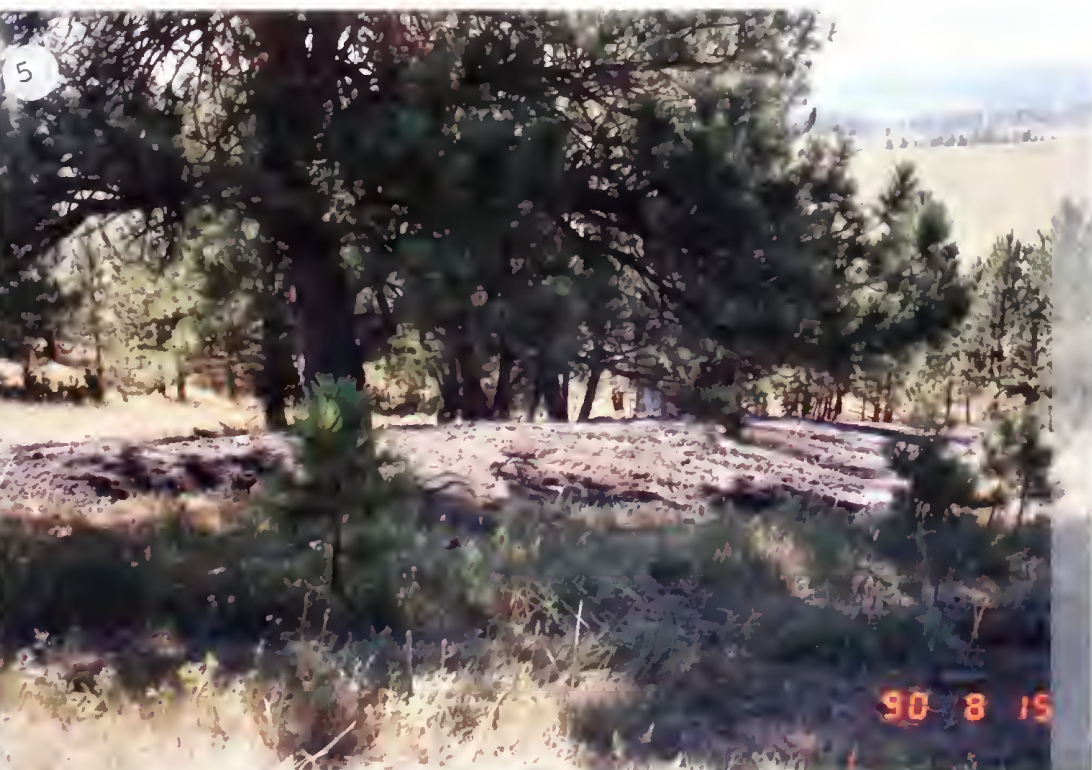
1. Shearson Mines - Site No. 3 After Construction
2. Shearson Mines - Site No. 4 After Construction
3. Shearson/Shipley Mines - West Adit Before Closure
4. Shearson/Shipley Mines - West Site Before Reclamation
5. Shearson/Shipley Mines - Middle Adit Before Construction
